**MOUNT HIGBY RESERVOIR DAM  
CT. 00140**

**PHASE I INSPECTION REPORT  
NATIONAL DAM INSPECTION PROGRAM**

**FEBRUARY, 1979**

Identification No: CT 00140  
Name of Dam: Mount Higby Reservoir Dam  
Town: Middletown  
County and State: Middlesex County, Connecticut  
Stream: Fall Brook  
Date of Inspection: 8 November 1978

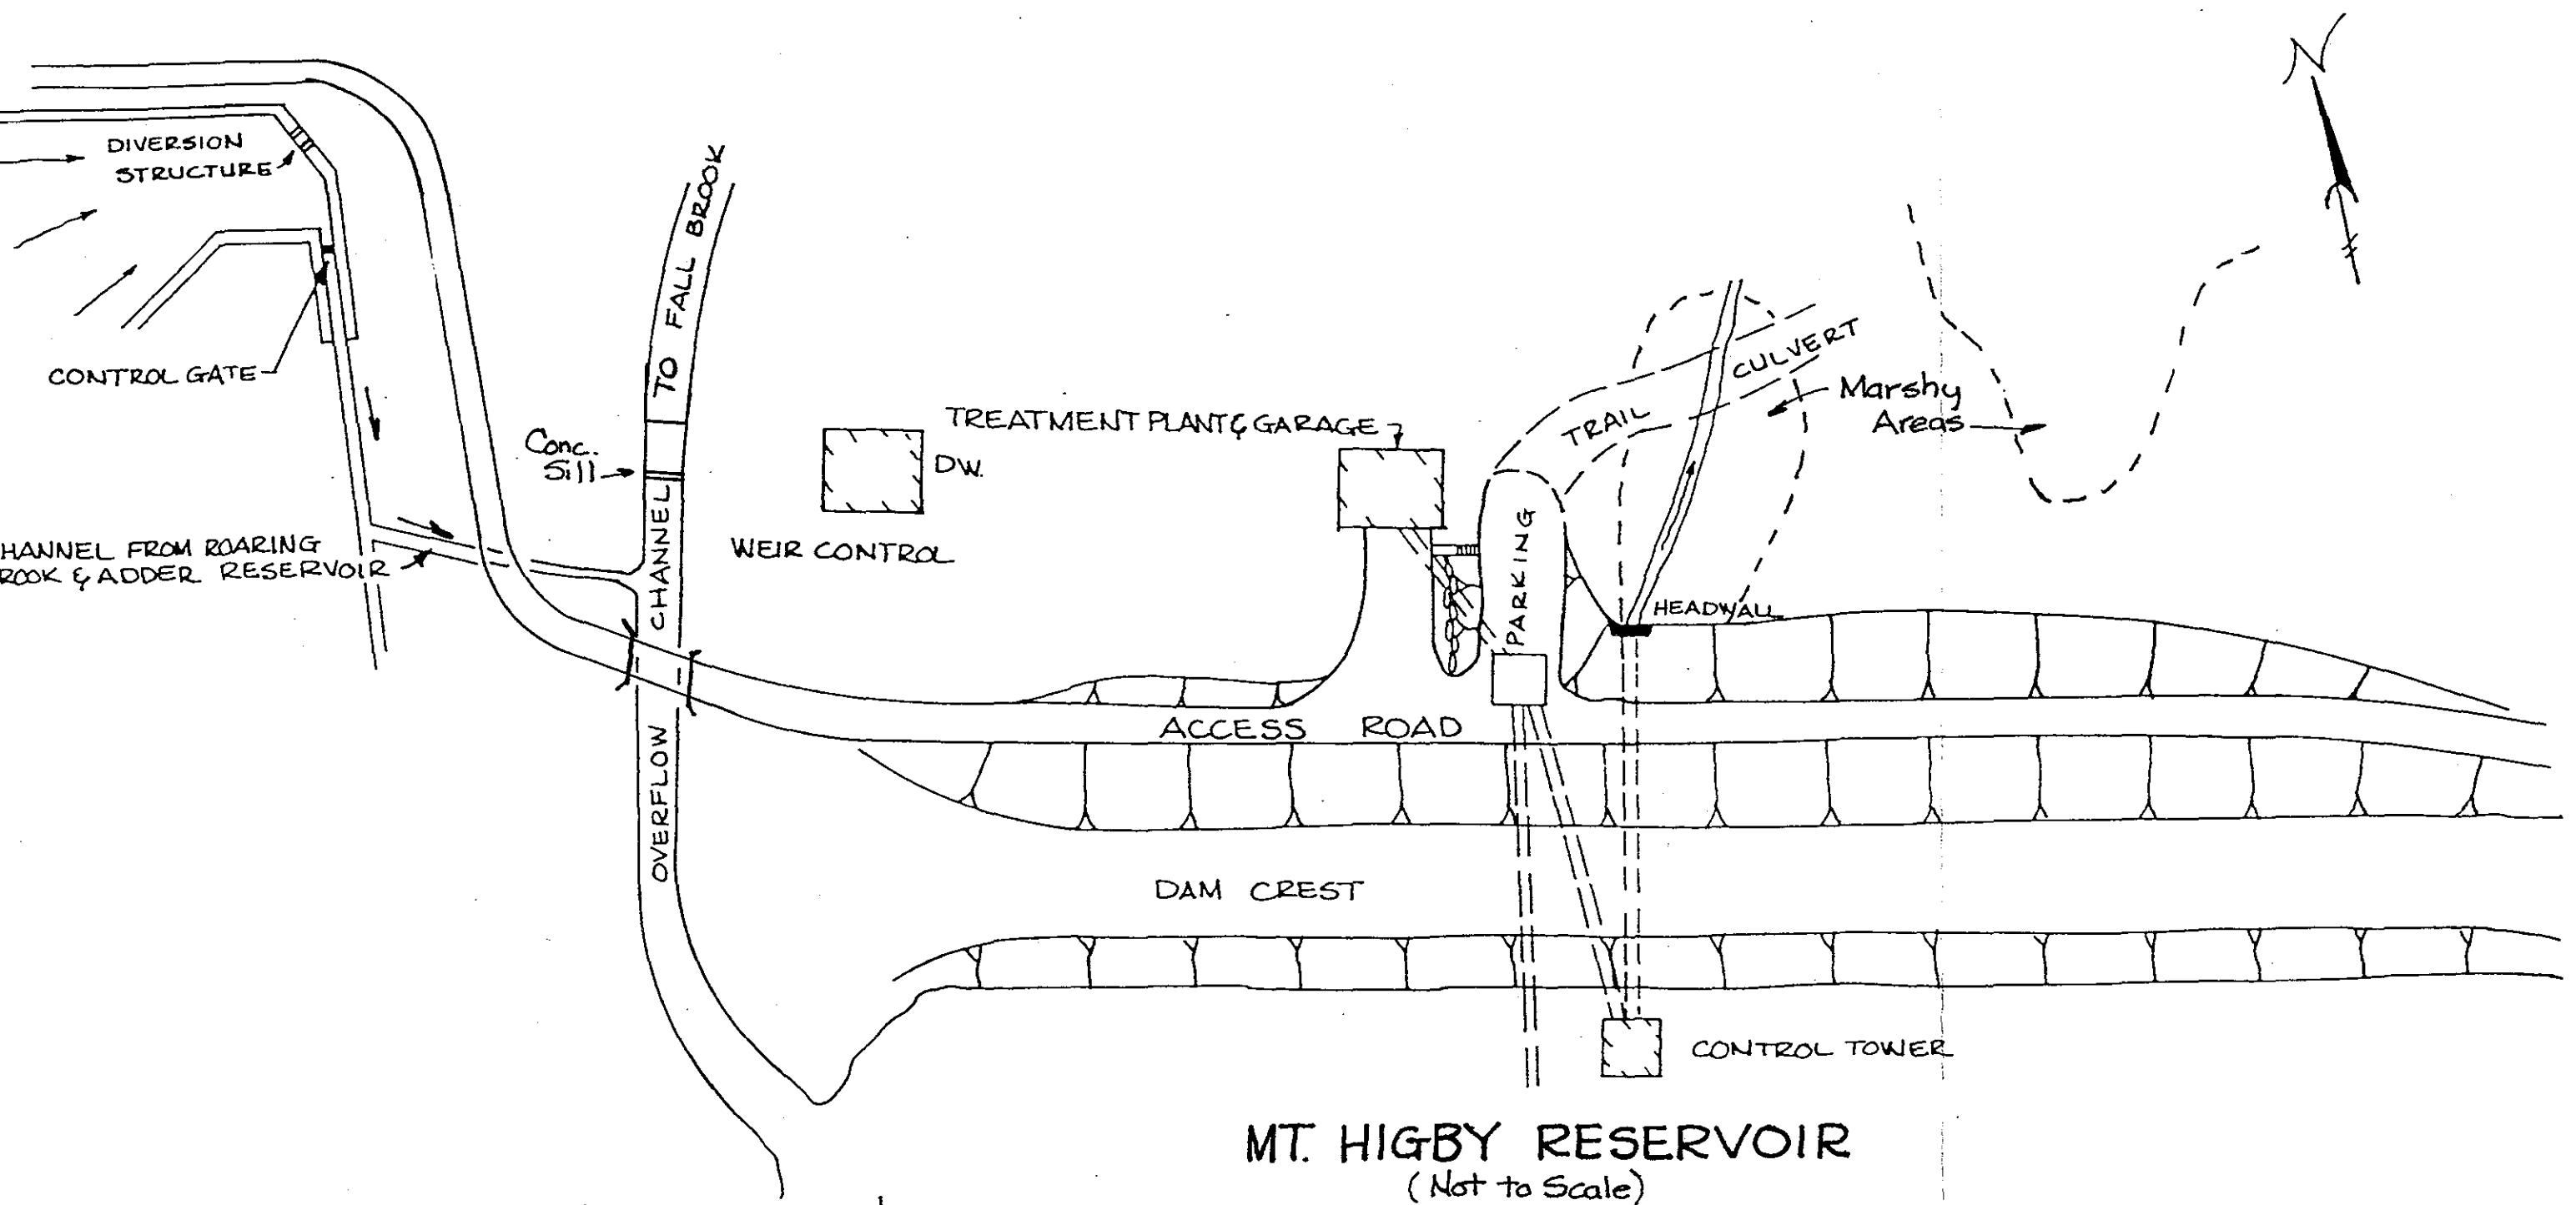
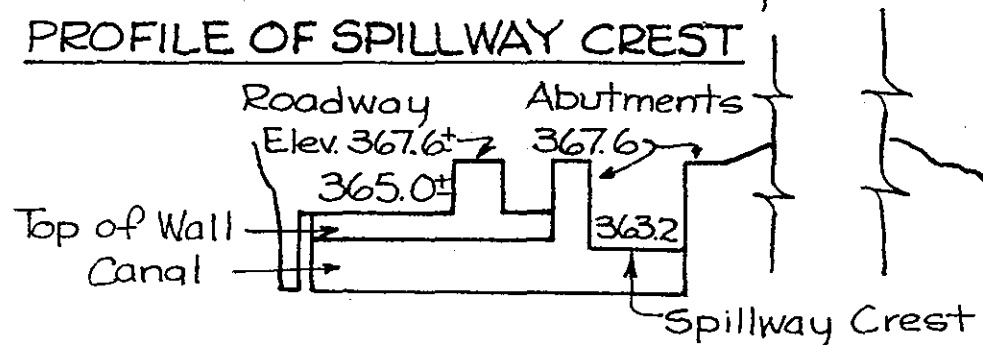
SKETCH PLAN & PROFILE  
 FIGURE 1 - SHEET D-1

The left abutment appears to be founded on bedrock, as evidenced from rock outcrops along the spillway channel. The right abutment foundation material is not known. Sketch plans and profiles of the dam and appurtenant structures are shown on Figure 1, Sheet D-1, Appendix D.

No data on the design of the dam or appurtenances has been recovered and probably none exist. In the course of the inspection, measurements were taken and a sketch plan and profile layout of Mount Higby Reservoir Dam and appurtenances has been prepared. These sketches are shown on Figure 1 in Appendix D.
